6
Ind-
National Dam Inspection Program. Twin
Lakes Number 1 Dam (NDS PA-00487,
Pennder 65-42), Ohio River Basin, Little
Crabtree Creek, Westmoreland County,
Pennsylvania. Phase I Inspection
Report.

TWIN LAKES NO. 1 DAM

PHASE I INSPECTION REPORT
NATIONAL DAM INSPECTION PROGRAM

11 APR 1979

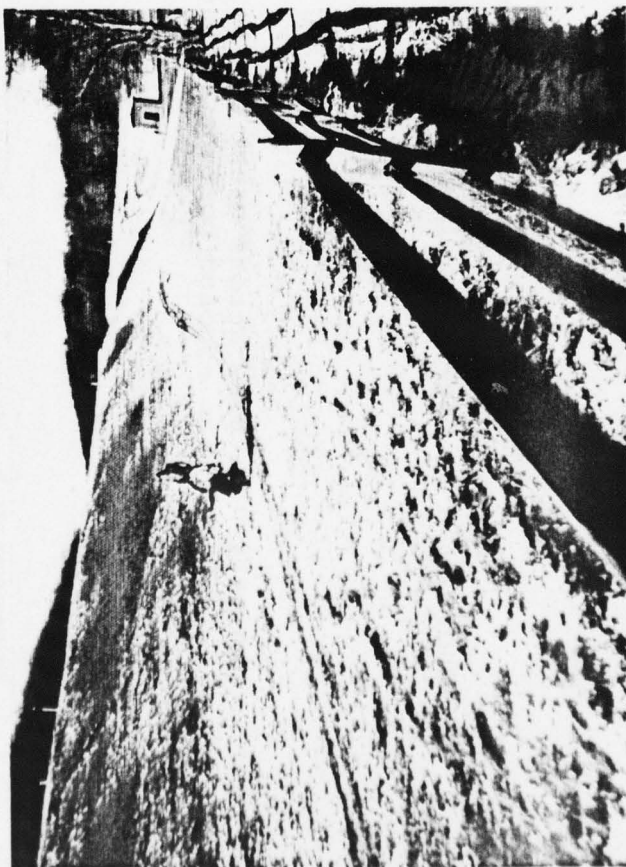
b. Embankment. The visual inspection suggests the embankment to be in good condition. Minor seepage, however, was observed along the downstream toe, particularly to the right of the spillway section (see Photograph 3). Despite the localized saturated areas, no signs of sloughing, erosion, or free flowing water were observed on or immediately below the embankment. A slag-gravel roadbed protects the crest against damage from occasional vehicular use. The downstream slope is covered with grass that requires little maintenance other than occasional mowing (see Photograph 1). The riprap is durable and well graded and provides adequate slope protection.

PHOTOGRAPH 3 View looking west along the downstream toe of the embankment. Inspection team personnel are within areas of noticeable saturation.

d. Monitor wet areas across the downstream embankment face on a continual basis. If seepage increases or turbidity occurs, the condition should be evaluated and necessary remedial measures implemented.

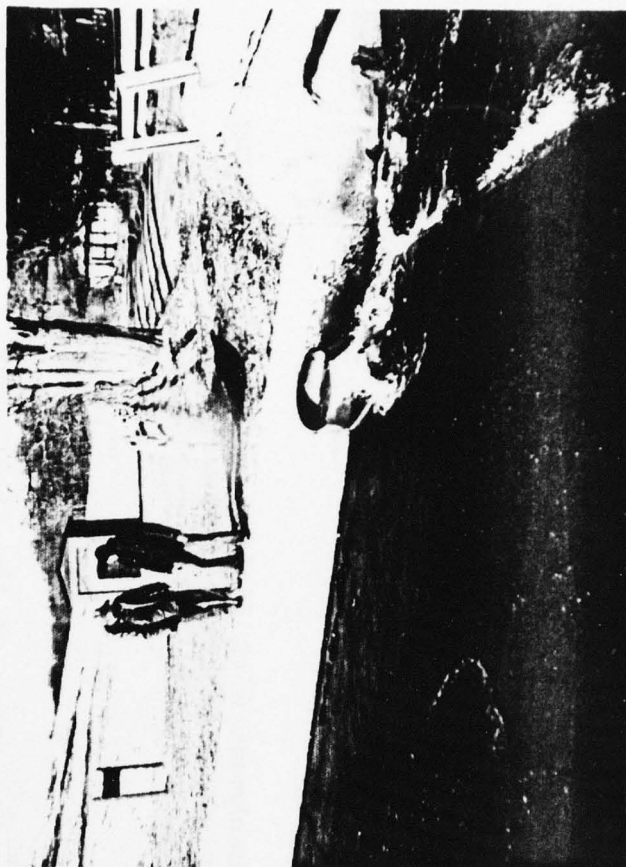
A manhole located on the crest just left of the spillway provides access to a 30-foot vertical reinforced concrete shaft, the bottom of which houses the manually operated gate valve. An extension on the valve stem permits operation from the top of the manhole. At the time of the inspection, the manhole was filled with water to elevation 1085.1 or approximately 5.9 feet below normal pool (see Photograph 10). Despite the flooded condition, the valve was operated by county personnel in the presence of the inspection team. The valve appeared to function normally as water was observed issuing from the outlet conduit at the base of the spillway channel (see Photograph 4).

PHOTOGRAPH 4 View of outlet works discharging near toe of spillway.

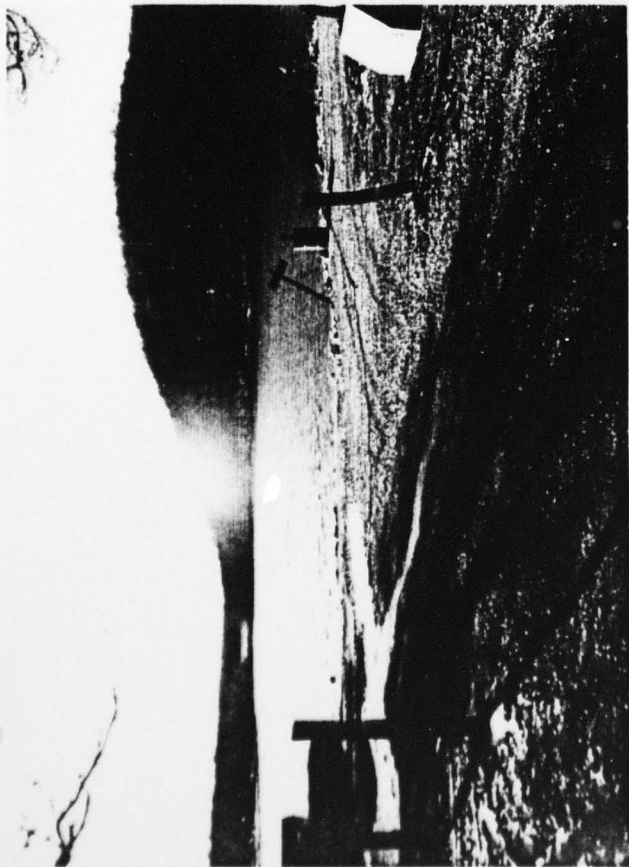
9

d. Reservoir Area. The general area surrounding the reservoir is characterized by gentle to moderate slopes that are partially wooded. No signs of slope distress were observed (see Photograph 9).

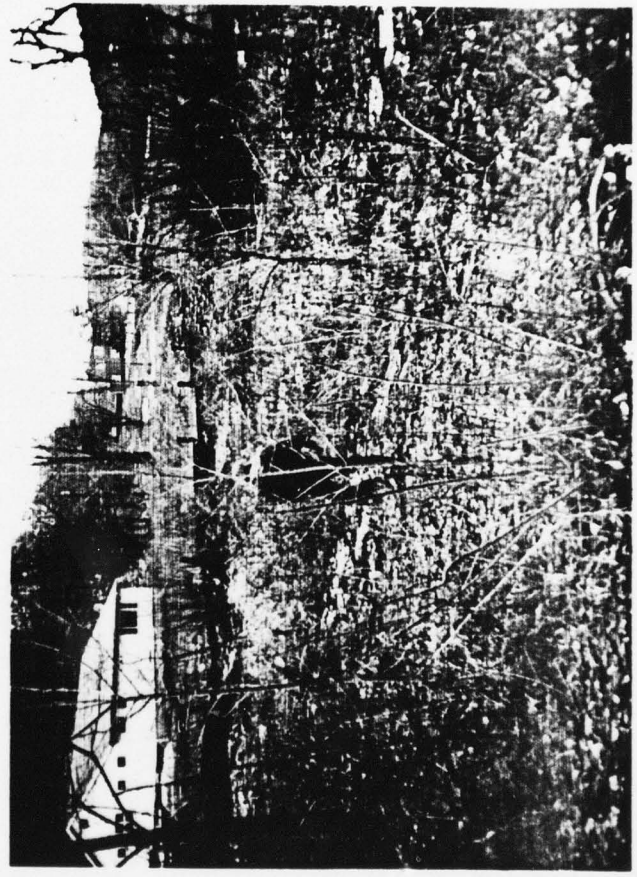
11

Flow discharged into the stream beyond the embankment follows a gently sloping course through a lightly wooded rural area. Approximately 2,500 feet downstream of the dam is the first house that could be affected by a dam failure (see Photograph 11). Many mobile homes are also located within the floodplain in this area. It is estimated that within this reach more than one hundred people could be affected by an embankment breach. Therefore, the hazard classification of the facility is considered to be "high".

View, looking south, of a permanent dwelling approximately 2,500 feet downstream of the dam.
